# **WATER DAMAGE ASSESSMENT**

**Worcester Public Library  
Basement Main Stacks, Storage, and Offices  
3 Salem Street  
Worcester, Massachusetts**

Prepared by:  
Massachusetts Department of Public Health  
Bureau of Environmental Health  
Indoor Air Quality Program  
June 2019

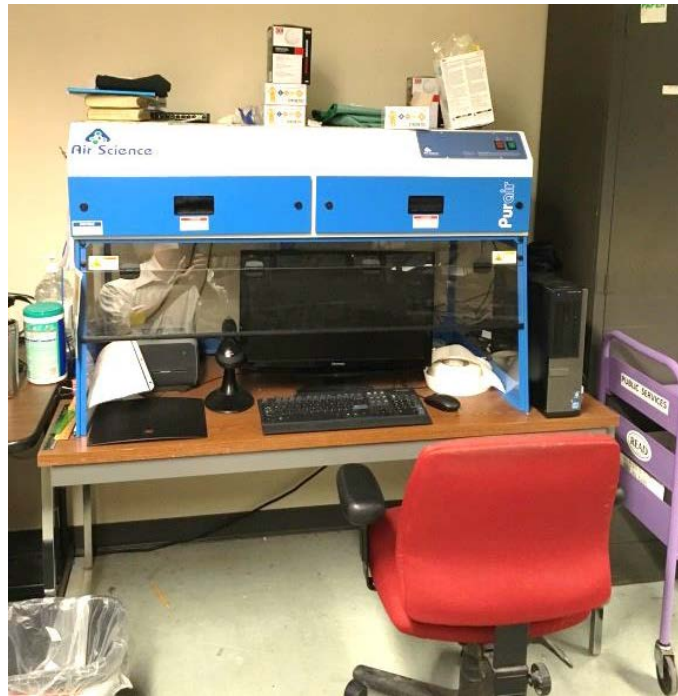
**Picture 1**

Employees directly handling possible mold-contaminated materials can be protected by several means. The most efficient manner to provide respiratory protection is to use a hood (Picture 1), which draws air away from the employee into the hood the air is then filtered and vented. Employees handling books during the assessment process should wear protective, non-latex gloves as well as long-sleeved work jackets to prevent dermal contact with possible irritants including mold.

**Book hood**

4. Operate the book hood during business hours.
5. Contact a contractor/building envelope specialist to examine whether the exterior walkway tiles can be sealed to prevent further water penetration.

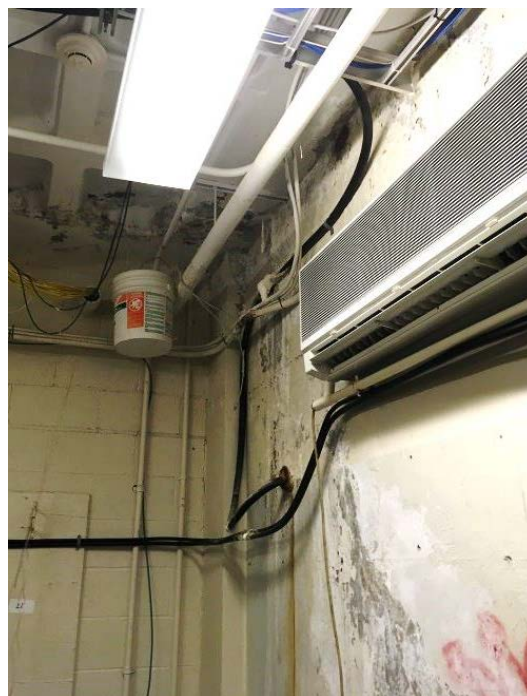
**Picture 2**

It is important to note that offices and hallways in the stacks were free of musty odors and there were no signs of water leaks through ceilings, walls or the floor in these areas. The area that contains the telephone service did have water-damaged walls and ceiling (Picture 2; Table 1) attributed to cracks in tiles in the exterior walkway above this area (Picture 3). This water damage does not appear to directly affect the book collection, but may be a contributing factor to increased humidity in the basement during hot, humid weather.

**Cement water damage in the telephone room**

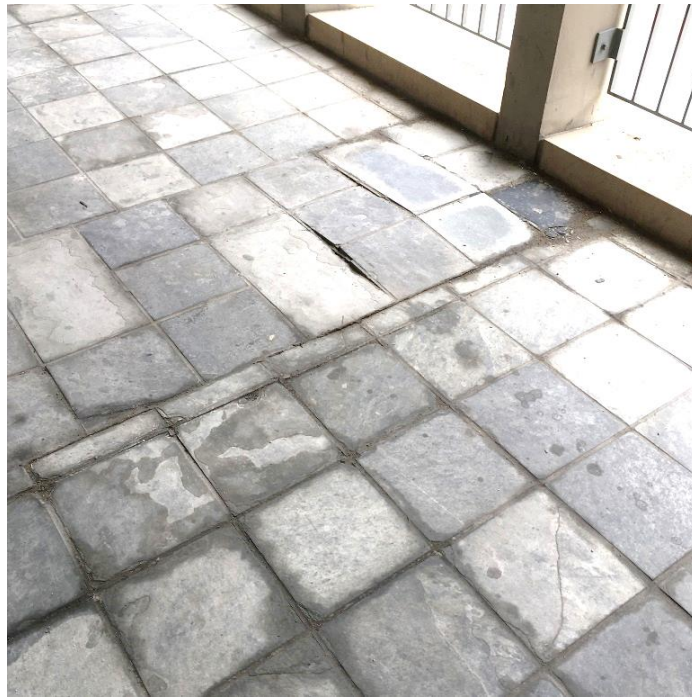
**Picture 3**

**Damaged walkway tiles above telephone room**

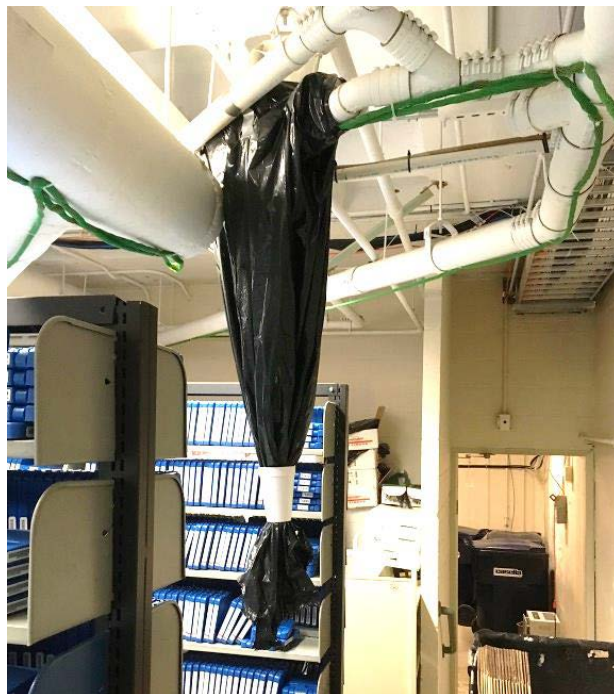
**Picture 4**

Another source of water appears to be a leak in plumbing pipe (Picture 4). Accumulating water from drain leaks can evaporate which in turn may moisten nearby books.

**Leak from plumbing outside of telephone room**

6. Repair source of water leak in Picture 4.
7. Please note that the American Society of Heating, Refrigerating and Air-Conditioning Engineers (ASHRAE) states if relative humidity exceeds 70%, mold growth may occur due to wetting of building materials (ASHRAE, 1989). Monitor weather for predicted outdoor relative humidity over 70%; if duration last over 2 consecutive days, it is highly recommended to take measures to reduce relative humidity. These conditions are likely to occur during summer heatwaves in New England.
